**U.S. COAST GUARD
MARINE SAFETY OFFICE PORTLAND, MAINE**

SAFETY ALERT

Capsize/Sudden Sinking Advisory

No. 99-01
1/20/99

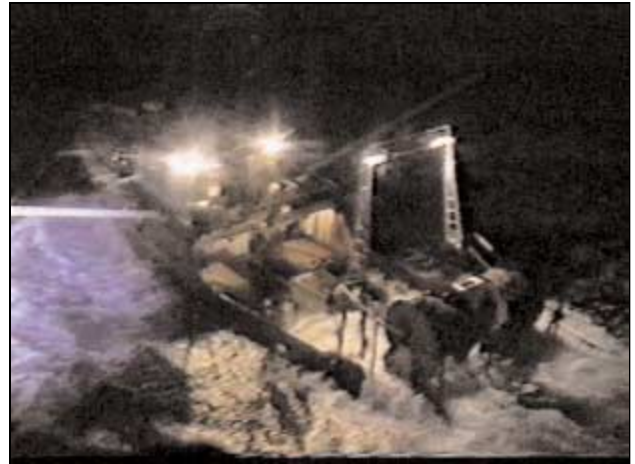
The Portland based AARON & MELISSA, December, 1993. While this vessel was lost, the survival of the crew is directly attributable to the integrity of internal water tight bulkheads, a functioning high water alarm system, functioning long range communications equipment, and flawless use of survival equipment by the vessel's crew.
